Tennessee Valley Authority  
Office of the Inspector General

# *Inspection Report*

## **REVIEW OF THE KINGSTON FOSSIL PLANT ASH SPILL ROOT CAUSE STUDY AND OBSERVATIONS ABOUT ASH MANAGEMENT**

2008-12283-02  
July 23, 2009

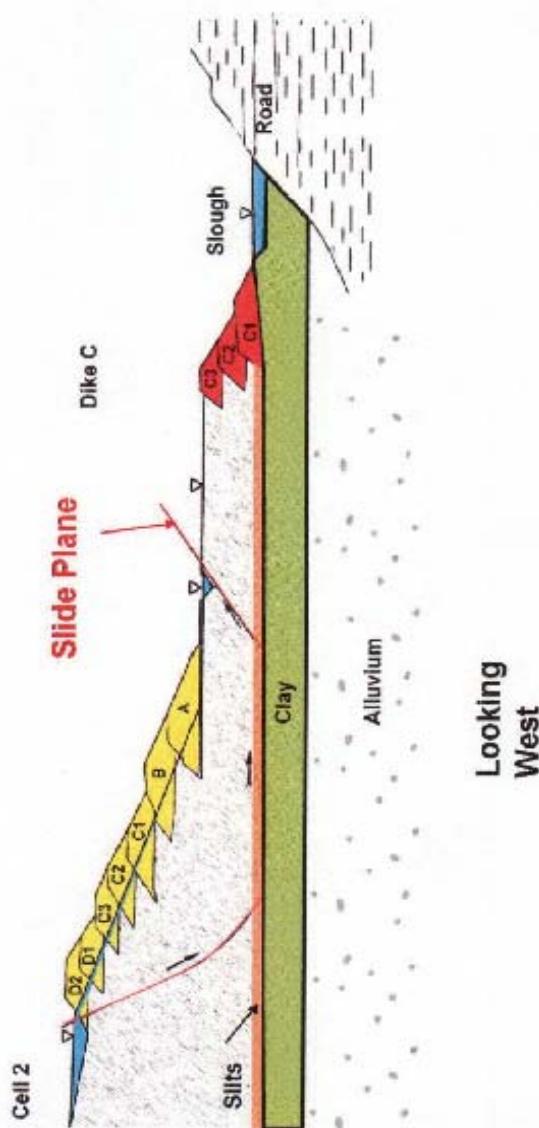
**Figure 3**

## **Stage 1 - Initiation of Failure at North Side of Dredge Cell 2**

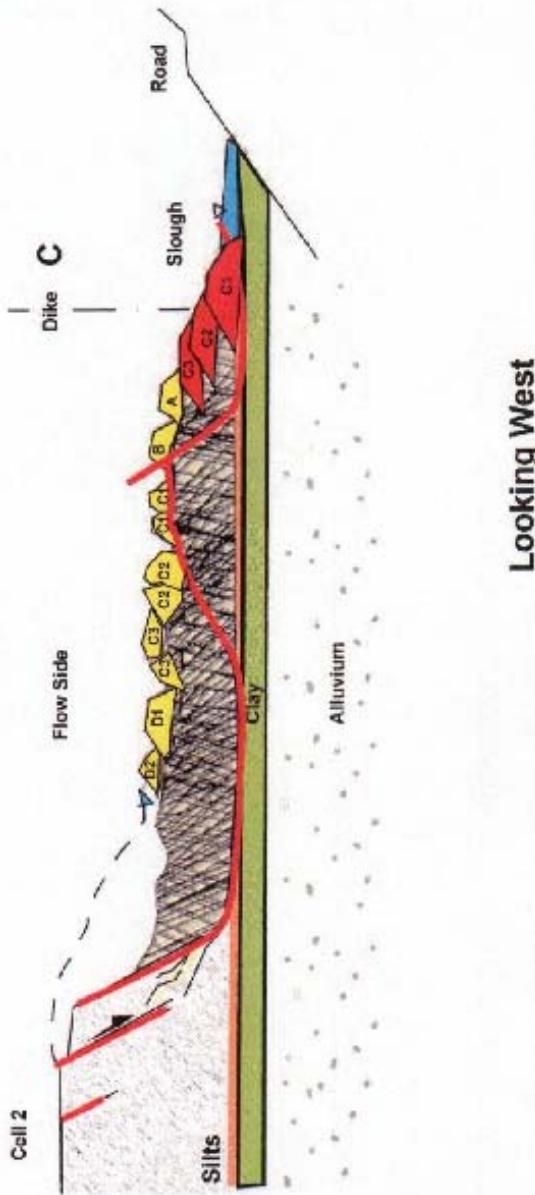
**Figure 4**

**Stage 2 – Ash & Dikes A thru D2 Pile Up Against Dike C.  
This Surcharge and increased Ash Pressure  
Causes Dike C to Fail**

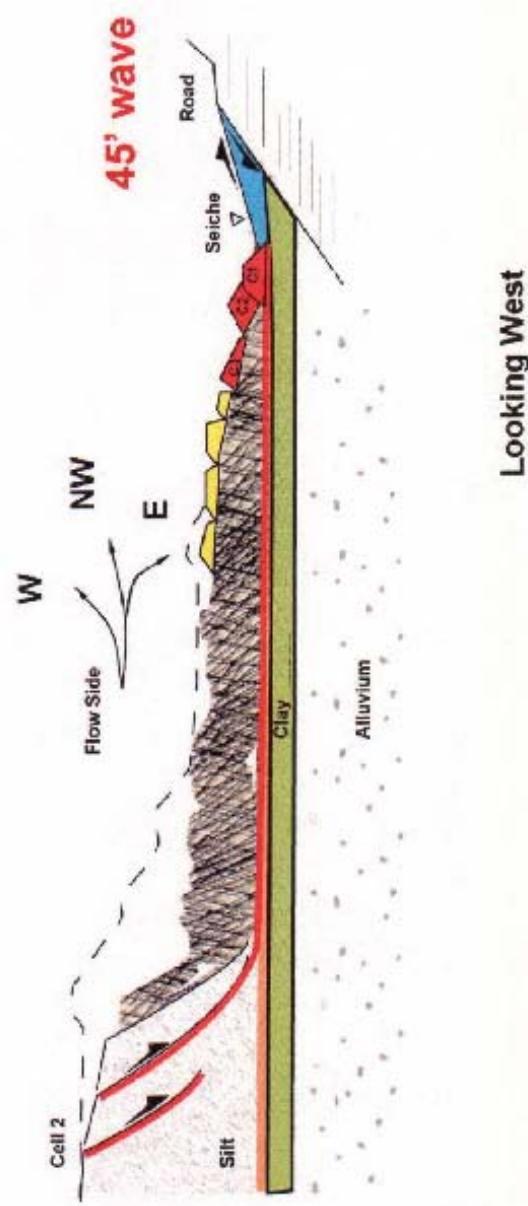
Figure 5

**Stage 3 – Progressive Failure Southward that Fails  
North Dikes A thru D2 Back to Cell 1 Divider  
Dike. 5.4 Million CY Fill Sloughs and Reservoir**
