# National Transportation Safety Board

## Highway Accident Brief

**Accident No.:** HWY-04-FH-039  
**Accident Type:** Median crossover, collision, and fire  
**Location:** U.S. Highway 75, Sherman, Texas  
**Date and Time:** September 20, 2004; 4:29 p.m. central daylight time

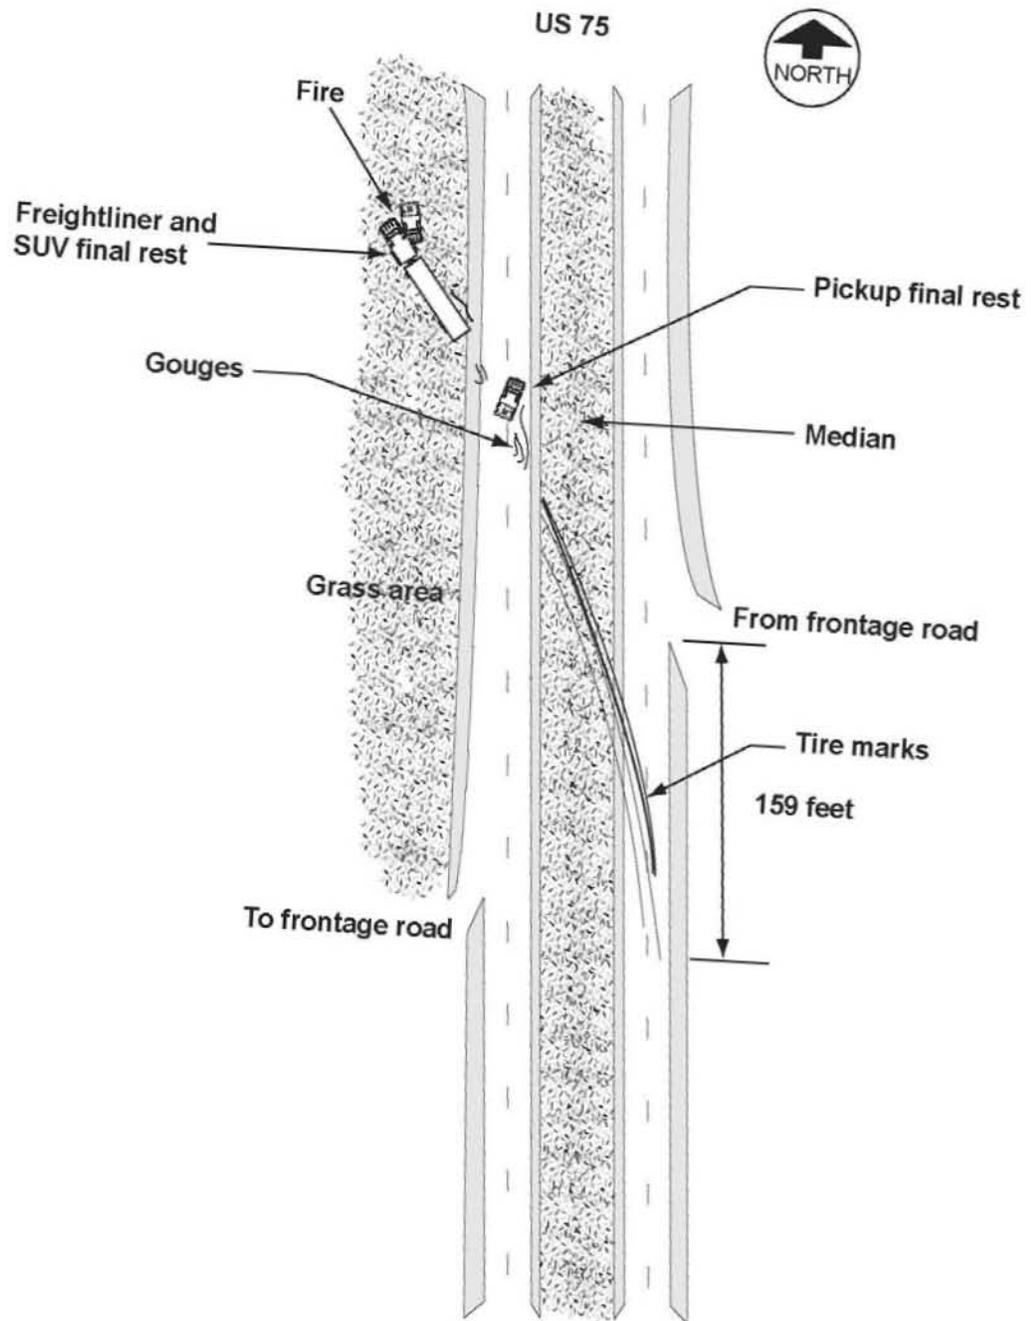
Tire marks from the accident scene, consistent with scuff marks,<sup>1</sup> indicate that as the Freightliner tractor-semitrailer approached the Farm-to-Market 1417 overpass bridge at a speed of 65–70 mph, it veered leftward from the right lane, crossed the left lane, and entered the

**Figure.** Accident scene diagram, adapted from Sherman Police Department sketch.

Immediately before the accident, the Freightliner driver was traveling in the right lane. The tire marks created as the tractor-semitrailer abruptly moved to the left were consistent with those caused by an evasive steering maneuver. The accident scene diagram (see figure) shows that the tire marks began about 159 feet prior to where an entrance ramp joined the main northbound travel lanes of US 75. Based on the Freightliner's overall length of approximately 50 feet, the front of the tractor would have been only 109 feet from the ramp at the inception of the tire marks. Witnesses reported the Freightliner to be traveling 65–70 mph, which would have placed it less than 1.15 seconds from the ramp. At least two witness statements place other vehicles in the vicinity of the entrance ramp. One vehicle was changing from the right lane to the left lane in front of the tractor-semitrailer, and the other vehicle was preparing to enter the highway at the entrance ramp. Although none of the statements suggested that these vehicles were a hazard, the Freightliner's tire marks show that the driver made an evasive steering maneuver in response to possibly perceiving the vehicles as being hazardous.
