Tennessee Valley Authority  
Office of the Inspector General

# *Inspection Report*

## **REVIEW OF THE KINGSTON FOSSIL PLANT ASH SPILL ROOT CAUSE STUDY AND OBSERVATIONS ABOUT ASH MANAGEMENT**

2008-12283-02  
July 23, 2009

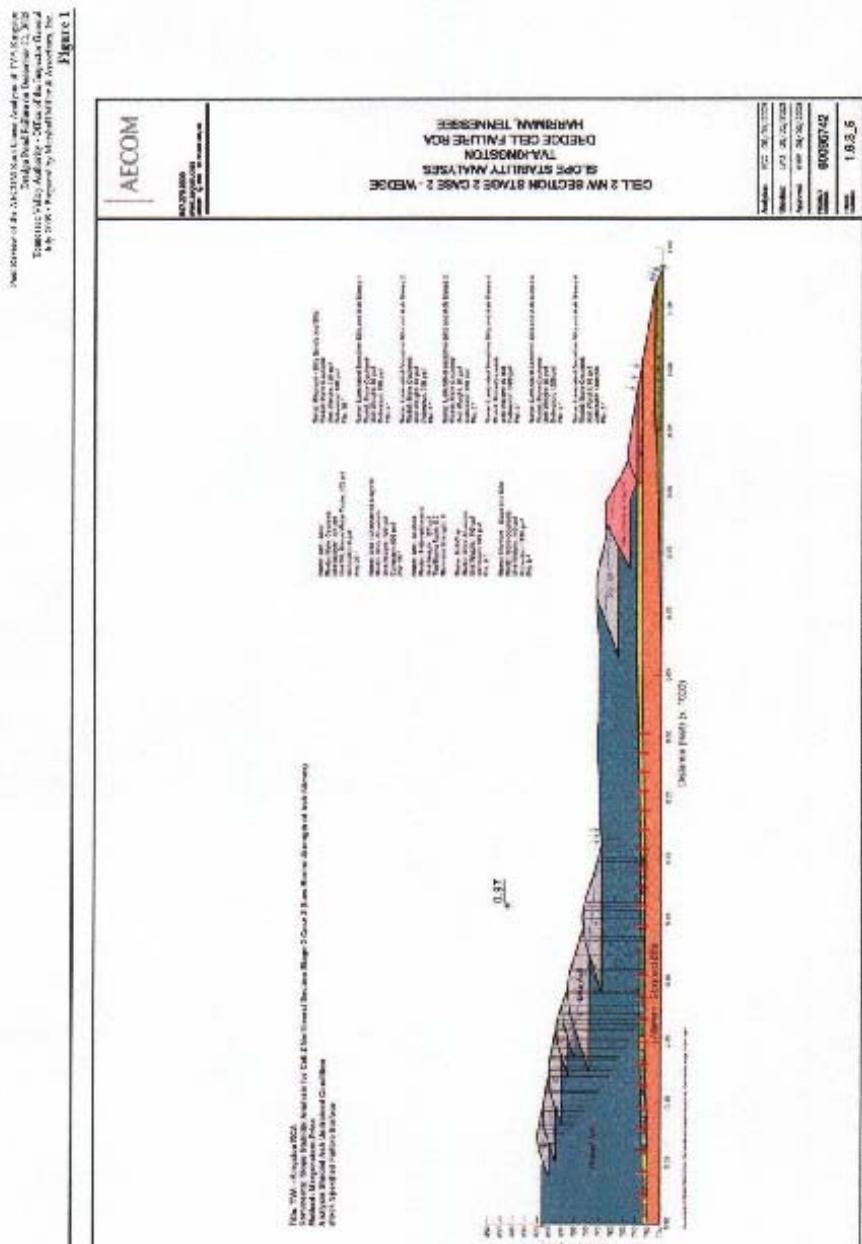
| Figure 1 | Cell 2 NW Section Stage 2 Case 2-Wedge -- Slope Stability Analyses |

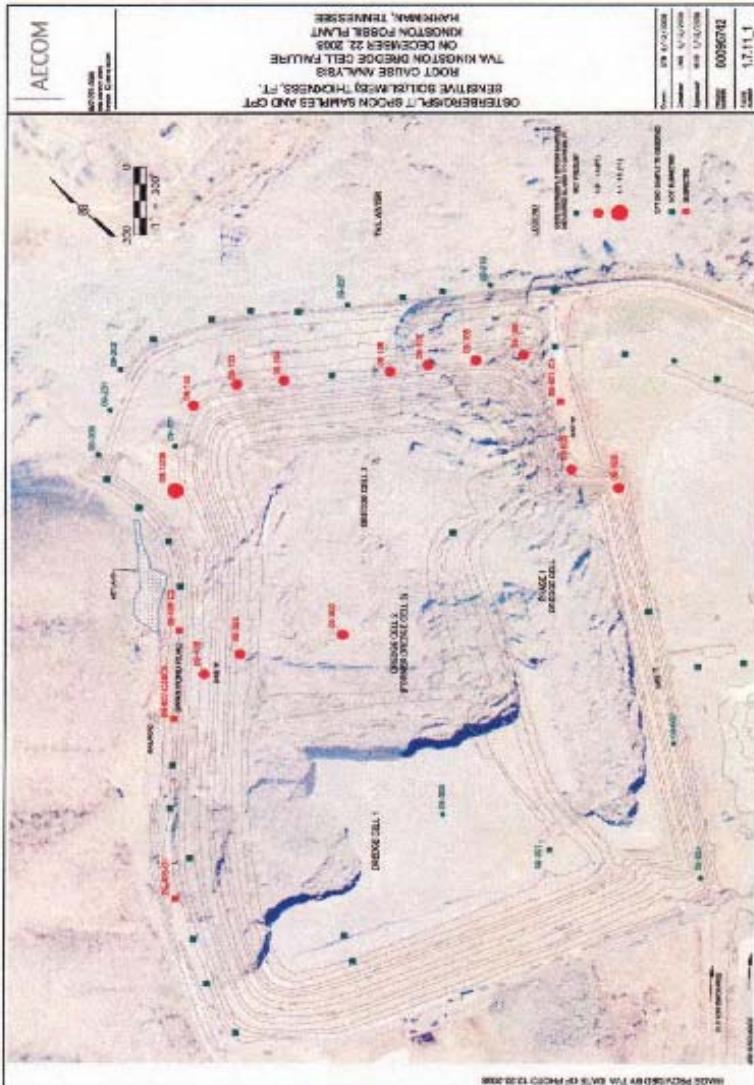
**Figure 2**  
Peer Review of the ATOMS Soil Gas Analysis of 1140 Kunkle Bridge Fund Project on December 12, 2008  
Tennessee Valley Authority—Office of the Inspector General  
July 2009 • Prepared by Volume 1 Miller & Associates, Inc.

| Figure 2 | Osterberger/Split Spoon Samples and CPT Sensitive Soil (Slimes) Thickness, Ft. |

AECOM discussed the thin layer of slimes beneath the dikes of Dredge Cell 2, per item 3 above, which was discovered during its subsurface investigation (see **Figure 2**). Slimes do not exist beneath Dike C. Although the properties of this slime layer suggest it as a potential slippage surface based upon mathematical modeling, it is MM&A's opinion that it is not the only possible slippage surface. AECOM documented that slimes were not found in some locations, were not of consistent thickness, and had properties very close to those of the ash material itself.
